**Safety Standards and Inspection Techniques  
For Natural Gas Composite Cylinders**

Craig Webster  
Powertech Labs Inc.

September 1999

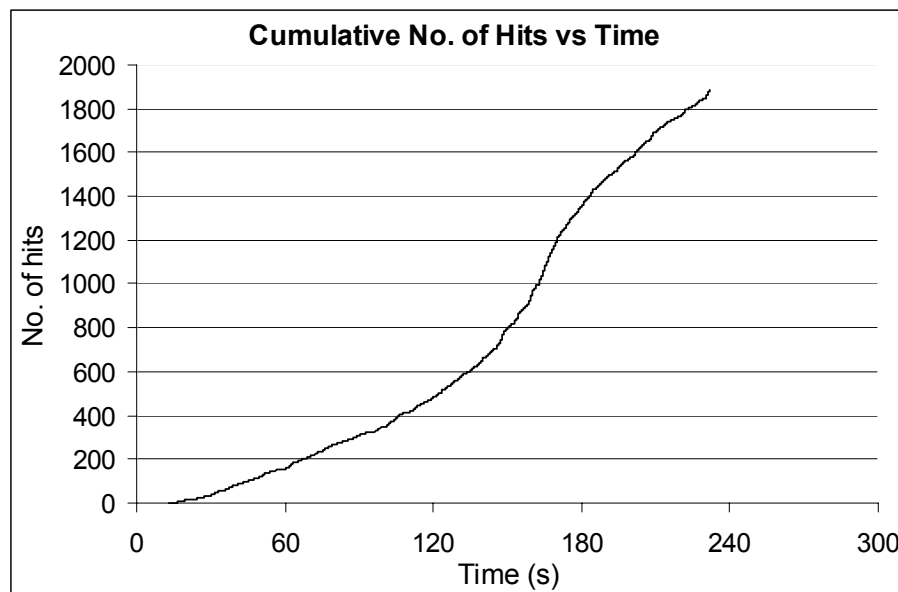
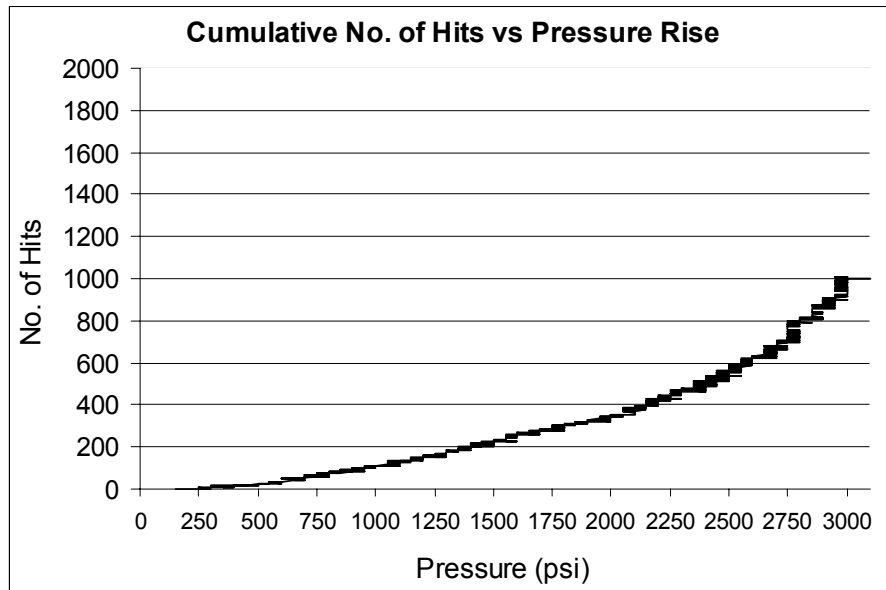
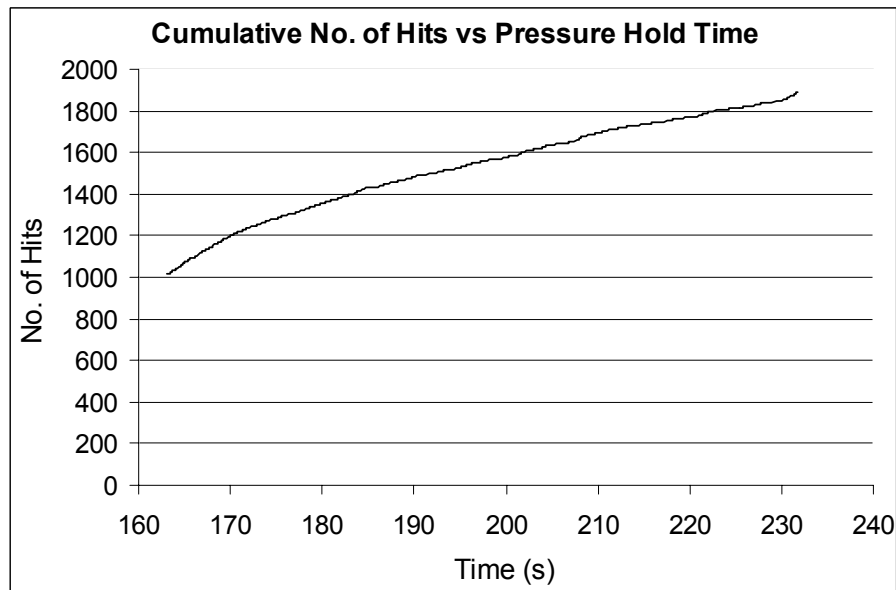
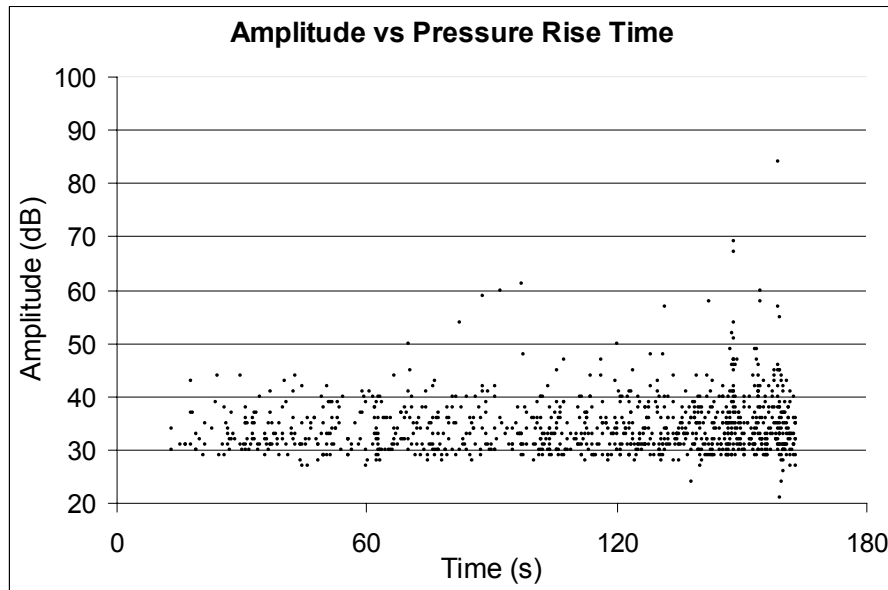
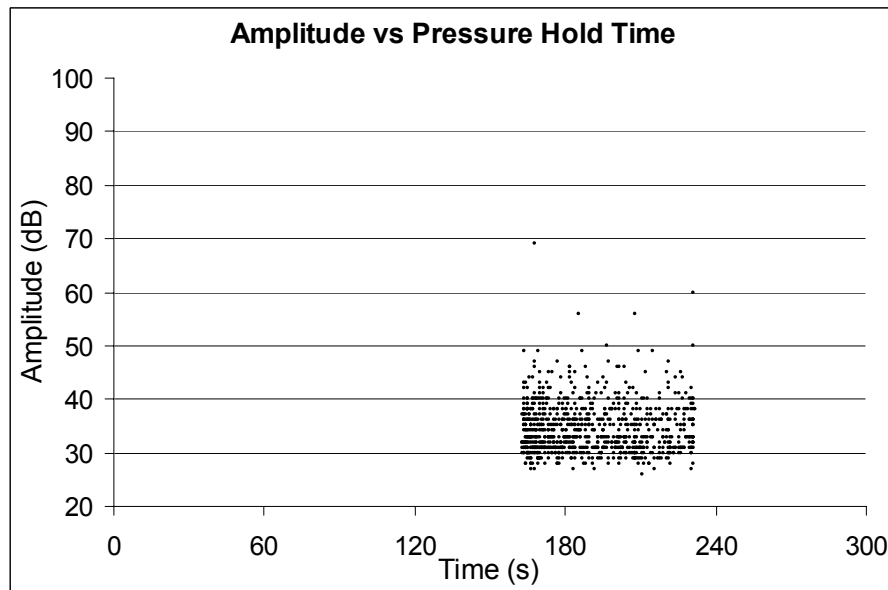
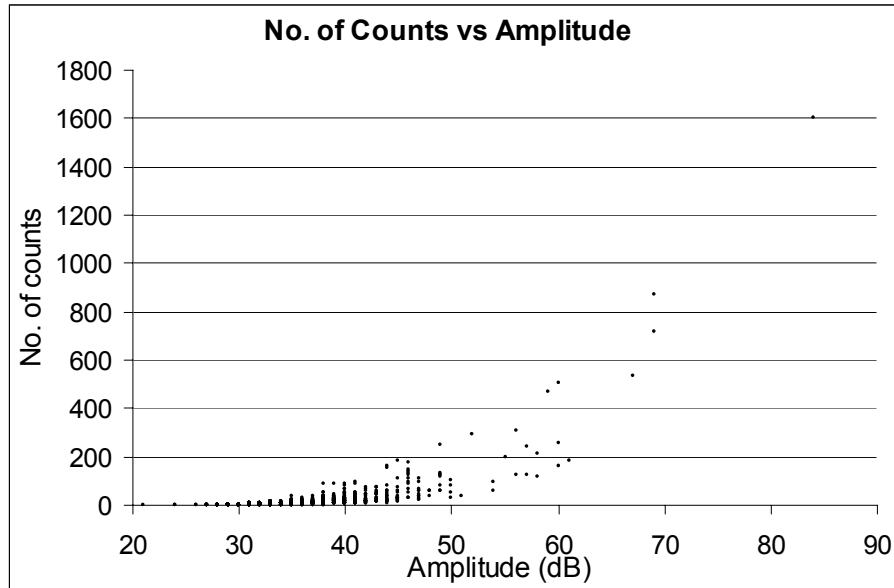
As the pressure increases, the cylinder expands and the different composite layers move against each other, creating the noise. It clearly proves that the cylinder is damaged. Secondly, the sharp increase in the AE activity occurring after 150 seconds is representative of further damage occurring to the wrapping during the test. Graph 6 shows a range of events with high amplitude at that precise time, which can be attributed to fibers breaking during the test. Thirdly, it is important to notice that during the minute when the load remains constant at 207 bar (3000 psi), the number of hits recorded continues to increase at the same rate. It shows that damage is still occurring to the wrapping, though the load remains constant. It indicates that the wrapping might be overloaded, and might be subject after a certain time to stress rupture. It is characteristic of a damaged structure, insofar as no damage should be created at service pressure on a normal cylinder.

The felicity ratio corresponding to these acoustic emissions is low 0.47, which indicates that the composite has been heavily damaged. The result of this test is that a monitoring the acoustic emission of the cylinder during a simple fill to the service pressure is enough to detect the damage to the structure, and to conclude that it would be unsafe to continue using this cylinder.

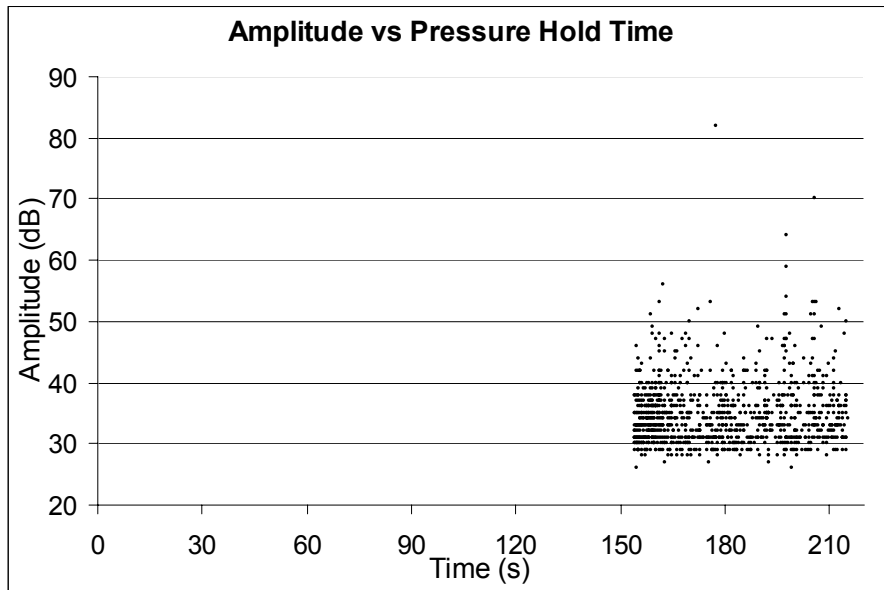
Graph 17: Amplitude versus Pressure Hold Time

We can notice on Graph 17 that there is one hit of very high amplitude occurring during the hold time. This means that fibers are breaking at constant pressure.

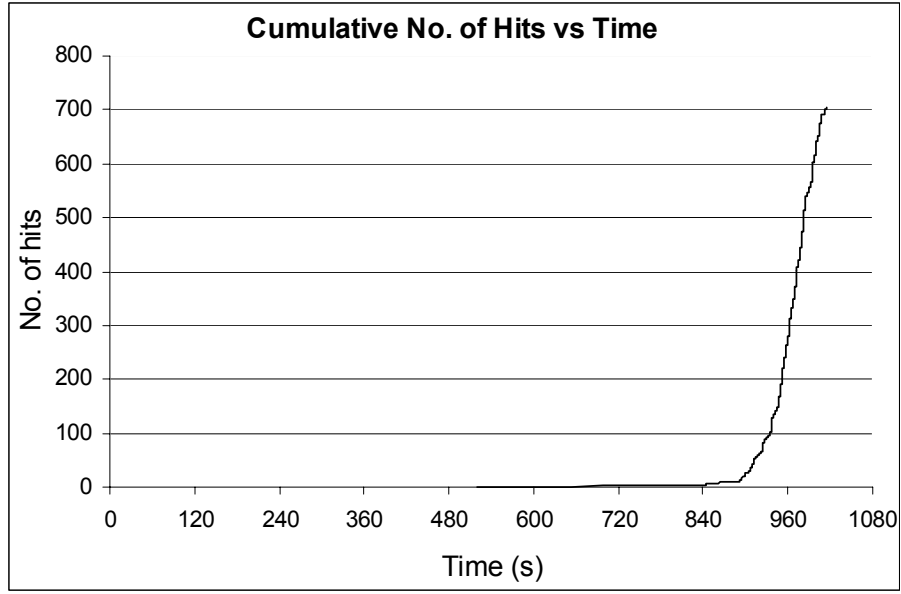
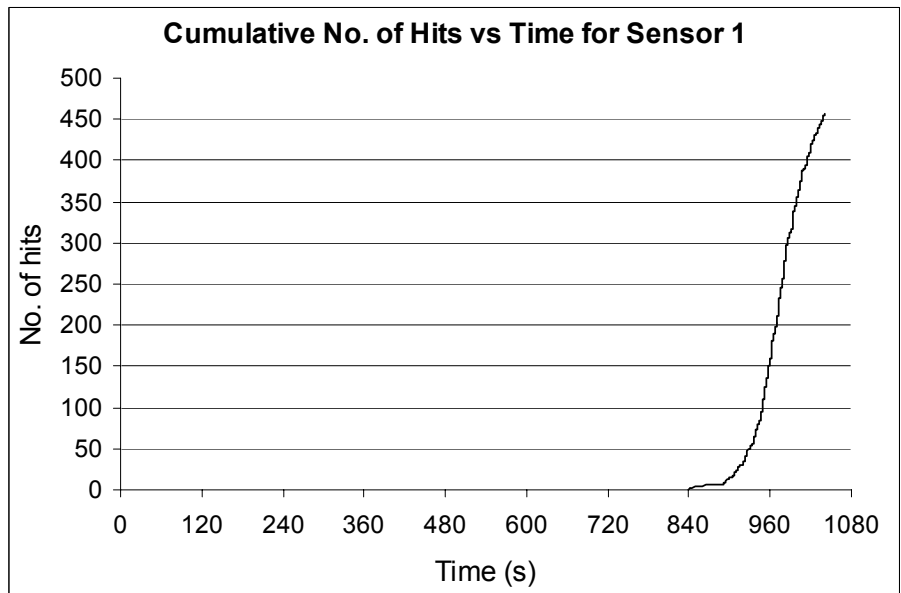
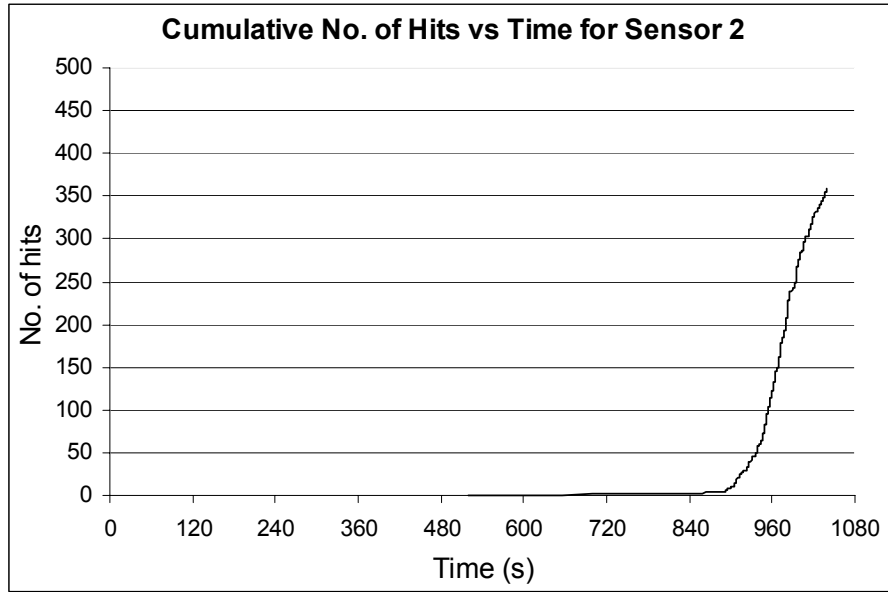
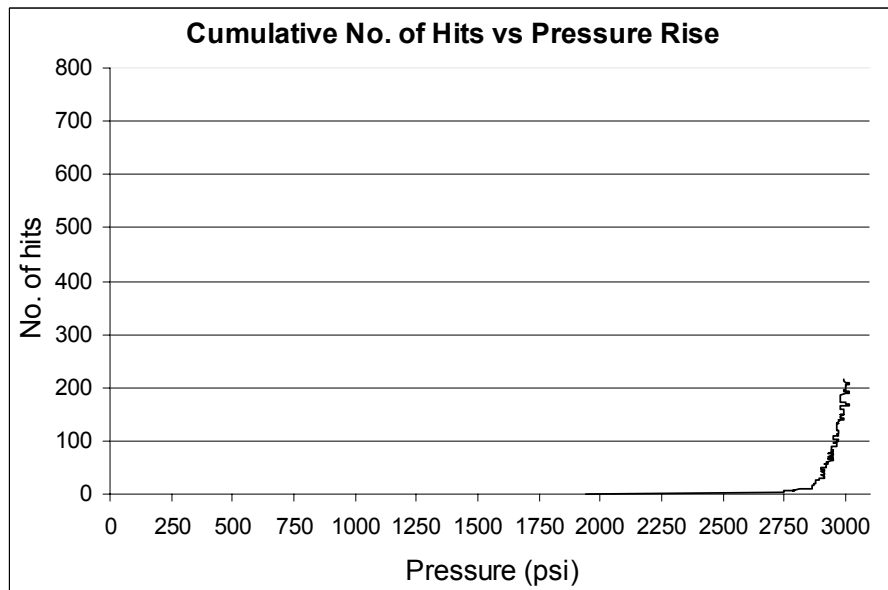
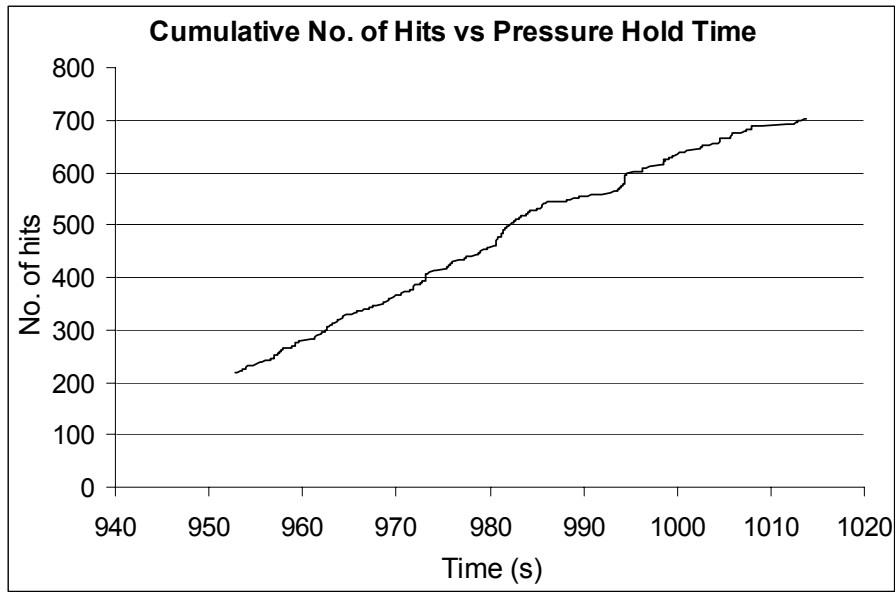
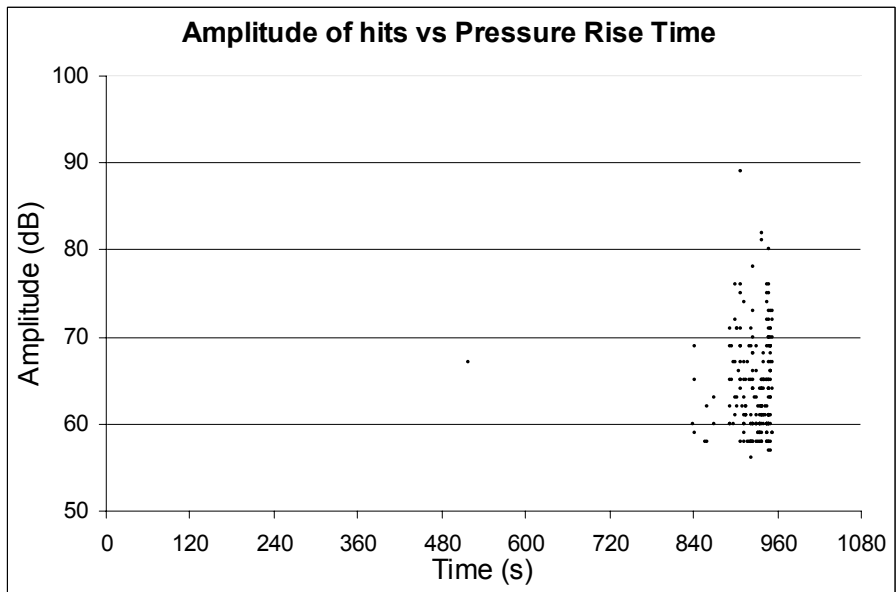
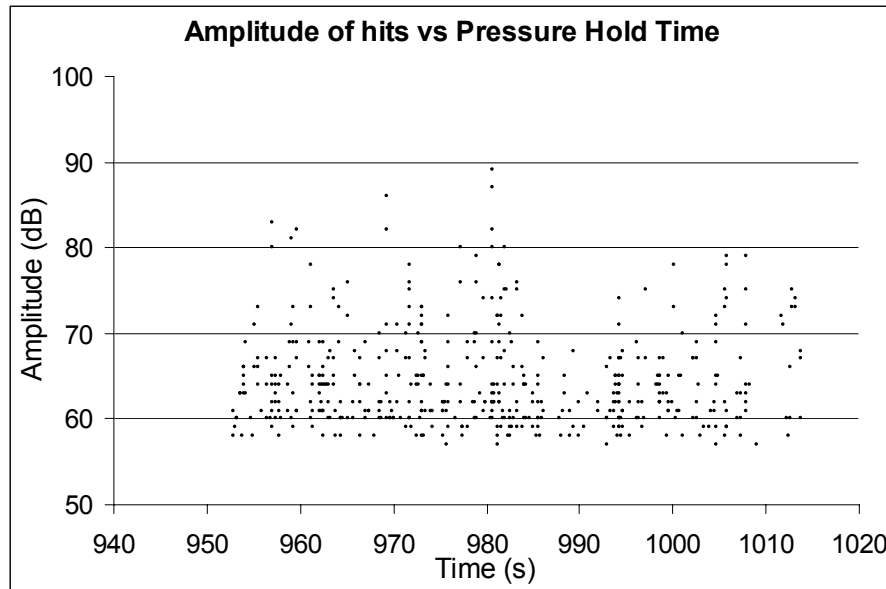
The inspection shows that the cylinder is undamaged. The acoustic emission is low until 193 bar (2800 psi), the response of both sensors is almost identical, and the felicity ratio is good: 0,91. Most of the activity occurs at the higher pressure. We can also notice that the range of the amplitude is quite broad. This can be explained by the fact that carbon fibers generally give greater amplitude to the hits than glass fibers. Moreover, there is no autofrettage on type 4 cylinders. This means that the liner can move inside the wrapping, creating rubbing noise.

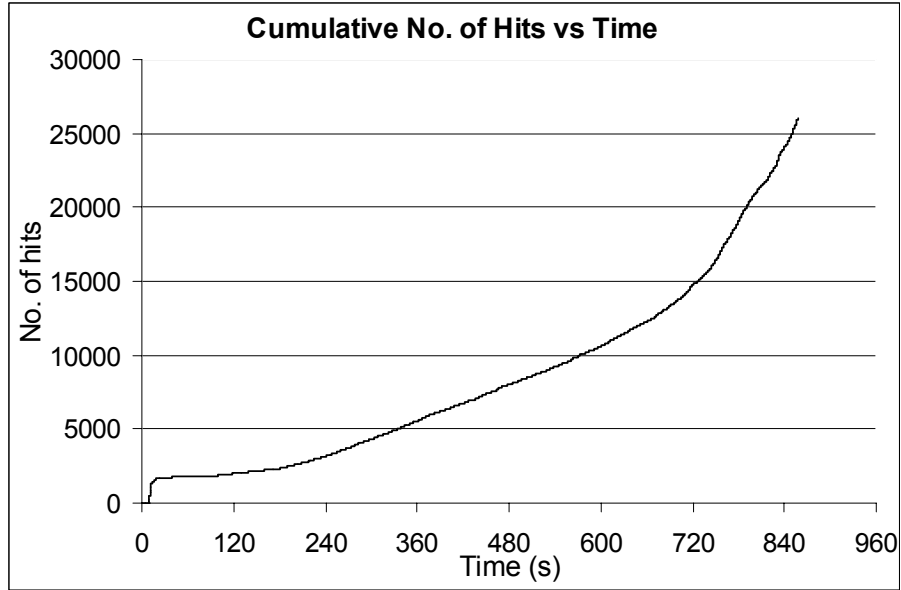
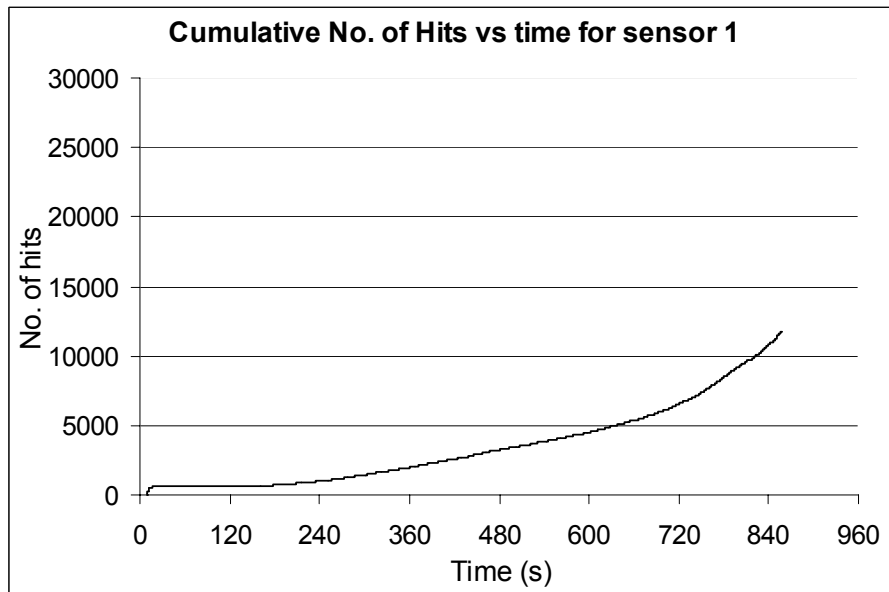
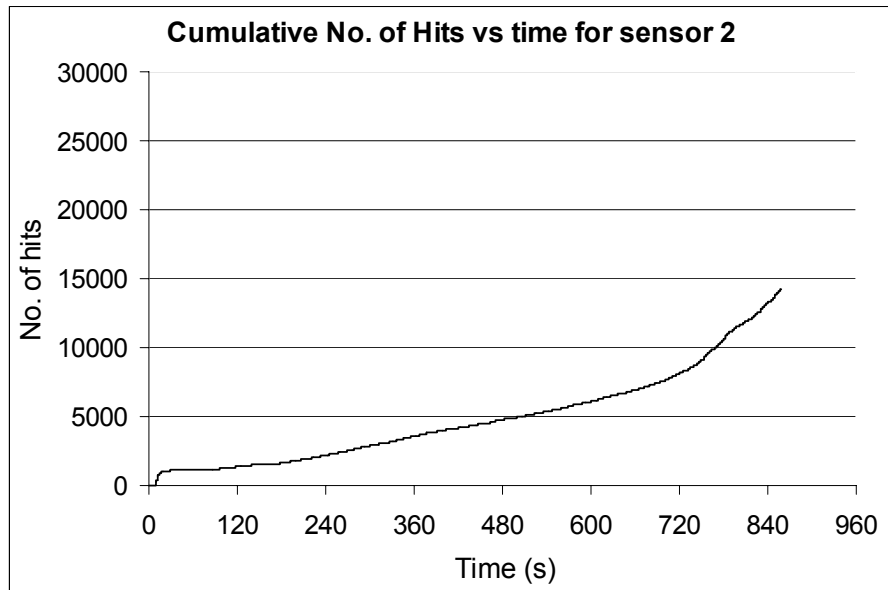
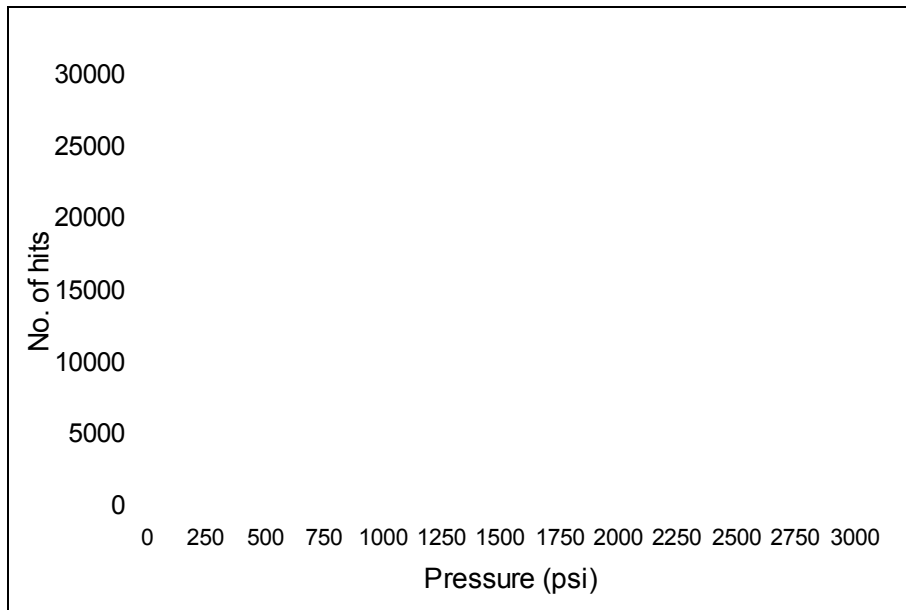
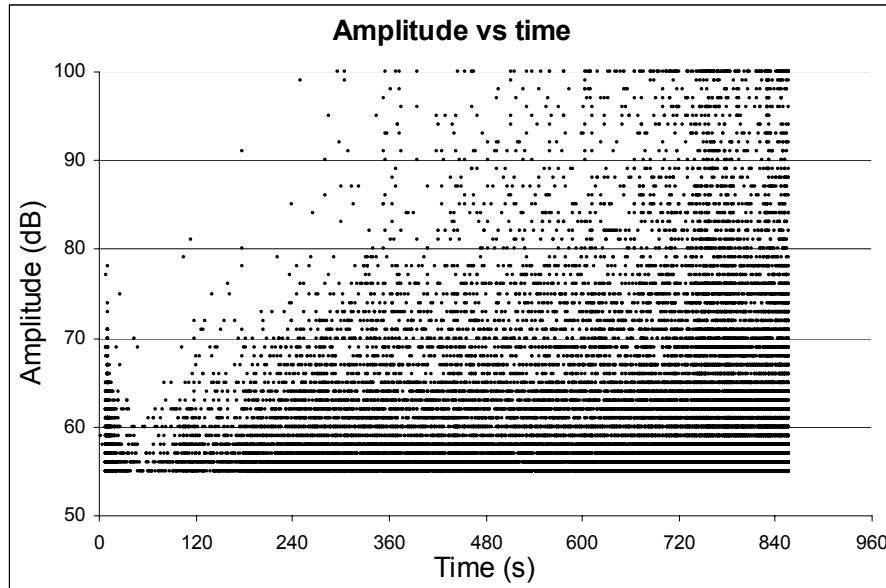
The cylinder failed during the first pressurization at 156 bar (2270 psi). However, the inspection of the acoustic emissions reveals some interesting points. The examination of the graphs reveals that there is a burst of AE at the very beginning of the test. For pressures still as low as 7 bar (100 psi), there is already about 2000 hits. These hits can be associated with the rubbing noise due to the delaminations inside the wrapping. With the increasing pressure, the cylinder expands, provoking this burst of events. It is characteristic of a damaged structure. It is obvious that the cylinder is damaged. The felicity ratio dropped to 0.02, which means that the material has lost almost all its strength.

The analysis also reveals that the number of hits is more important for the second sensor. This corresponds to the importance of the damages, and finally, the failure occurred on the spot of the second hit. There is a correspondence between the importance of the damage and the number of hits. The analysis of the amplitudes confirms the previous observations. We can notice an important number of hits of relatively low amplitude at the beginning of the pressurization. It corresponds to the frictional noise mentioned above. Then, the higher the pressure, the higher the amplitude of the hits, which shows that heavy damage is occurring to the composite during the test. It is possible to detect that the cylinder is damaged.

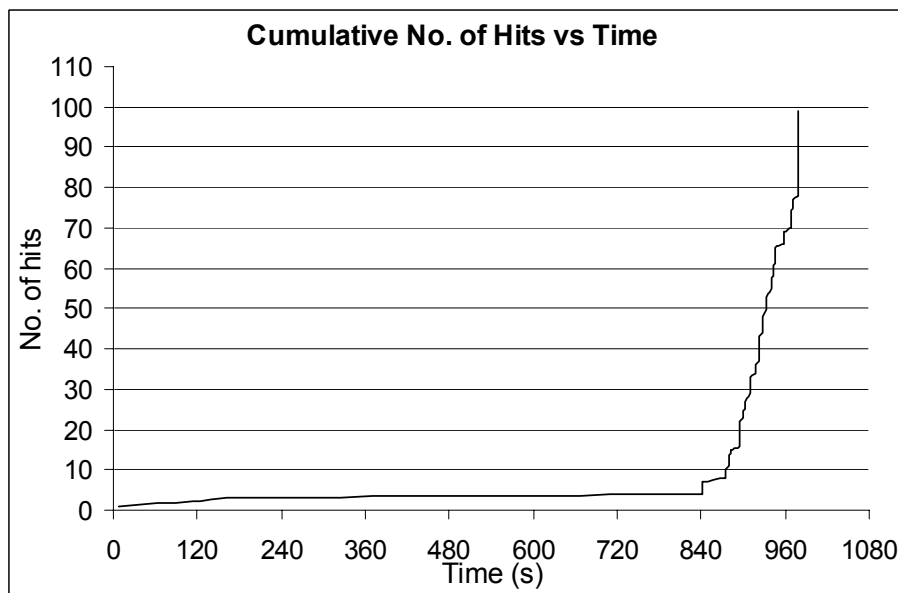
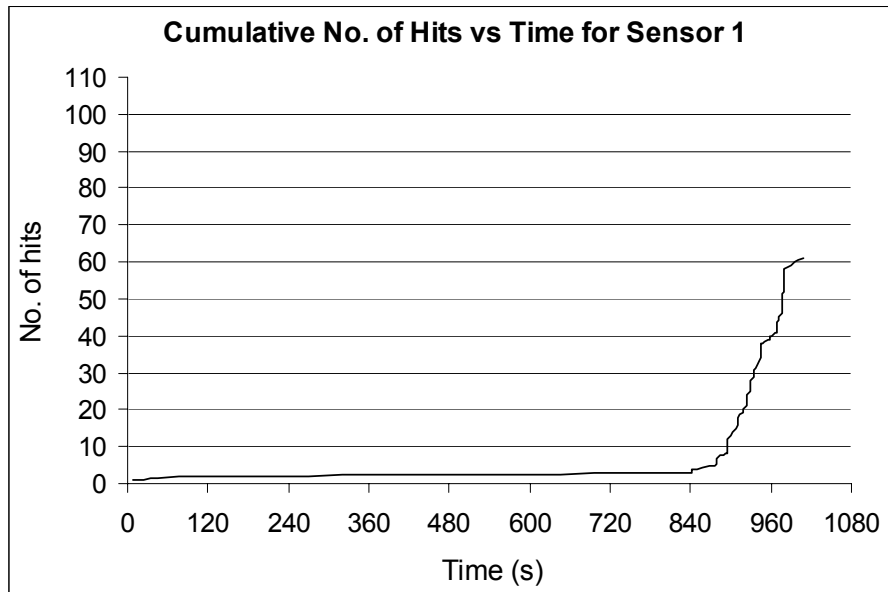
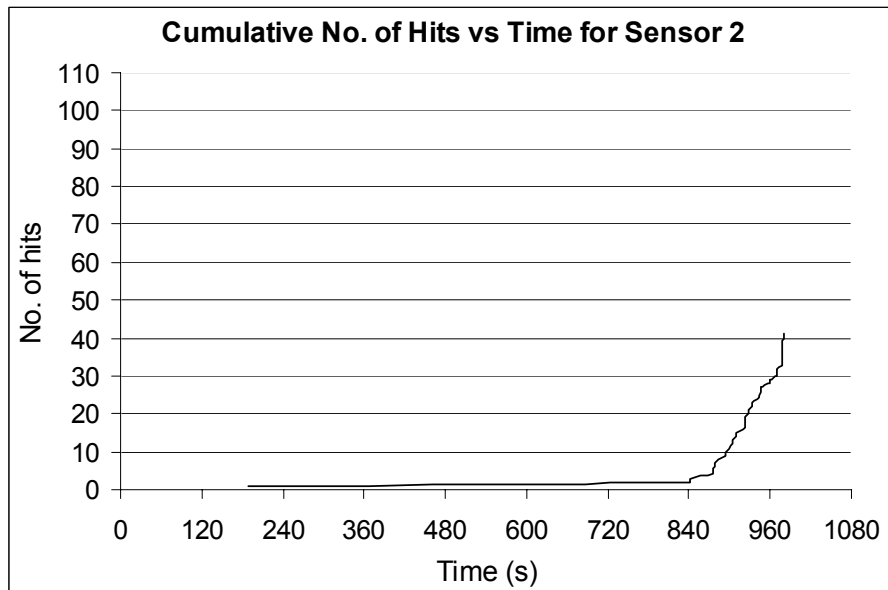
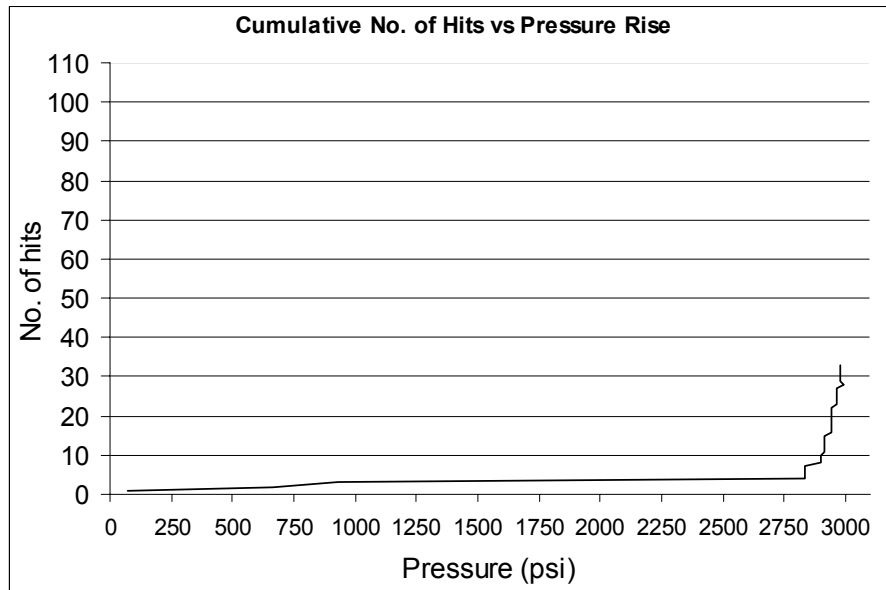
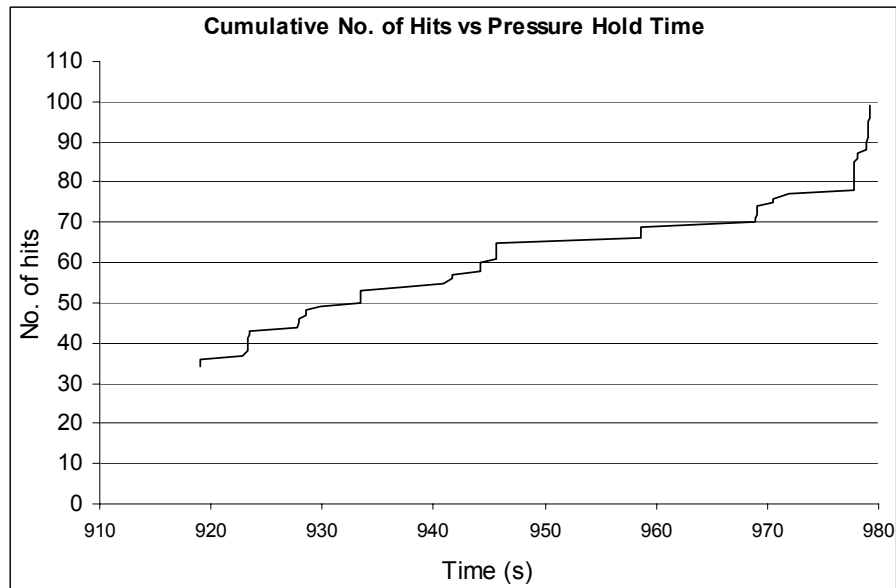
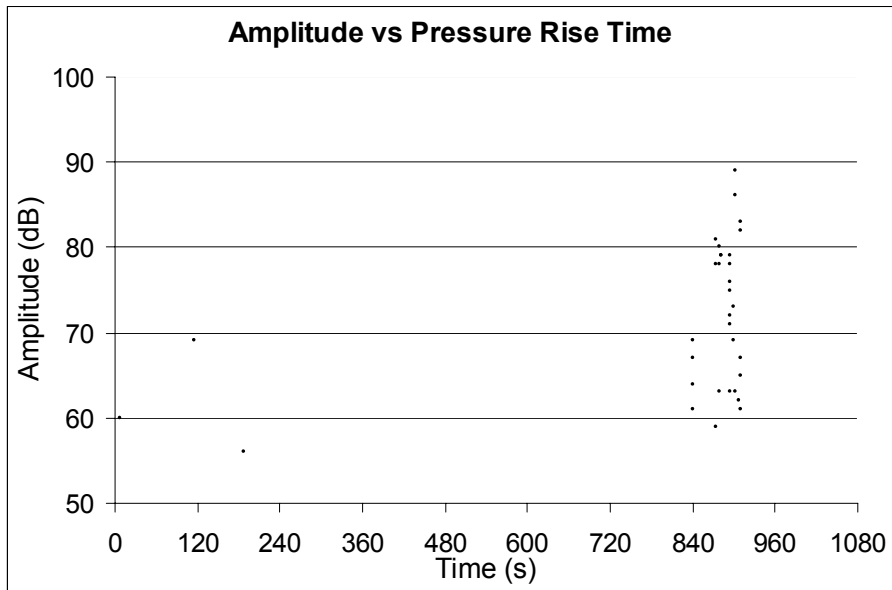
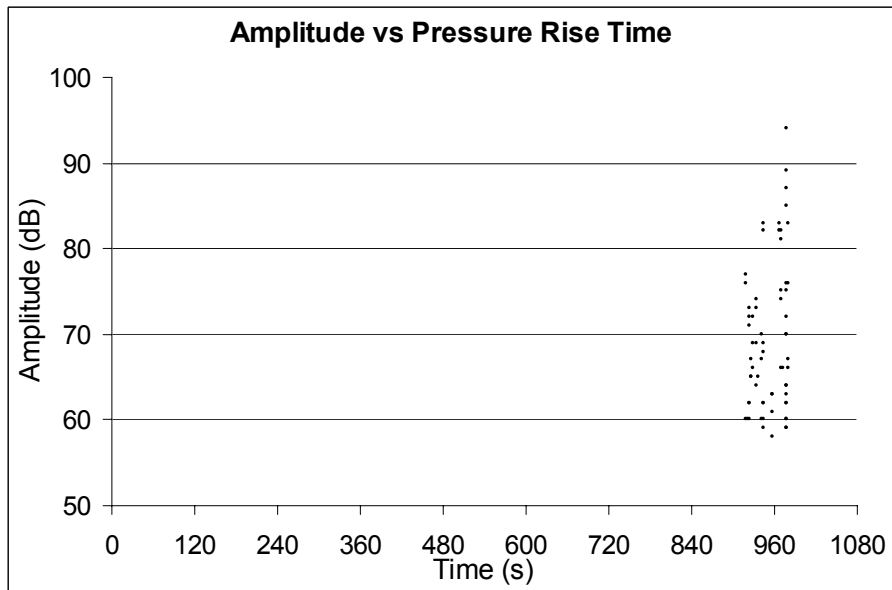
The inspection of the cylinder shows that it is undamaged. Indeed, the total amount of signals is low (about 100), the activity occurs at the highest pressure and the felicity ratio is good: 0.97. Moreover, we can notice that the activity slows down during the hold time.

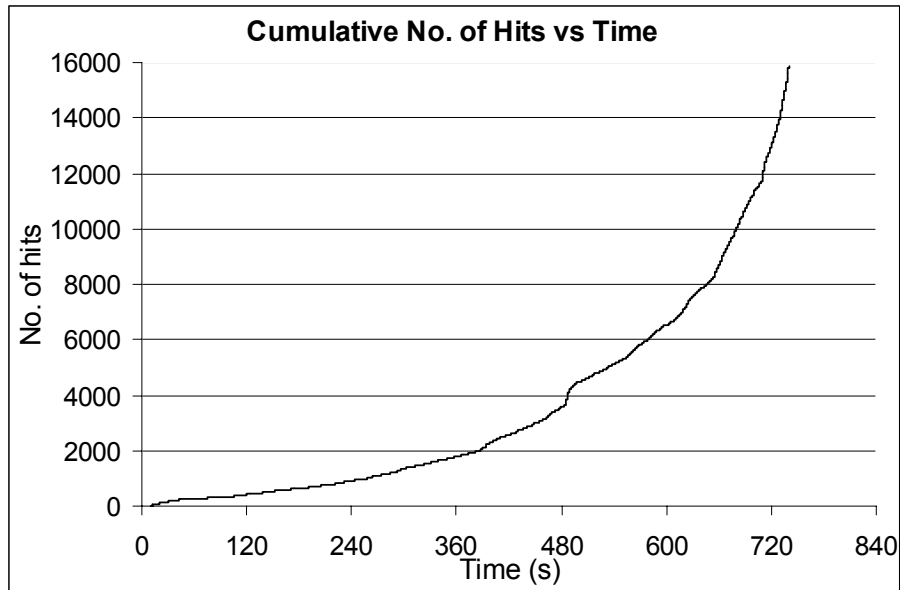
Graph 38: Hits versus Time for Both Sensors

The cylinder failed during the first pressurization after the drop test. The pressure at the failure was 156 bar (2260 psi). The examination of the curves reveals the same phenomenon as for the previous sample. A burst of acoustic emissions occurs at the very beginning of the test, but for sensor 1 only. It is less important but still shows that there is damage to the wrapping. The plot of the amplitudes confirms this showing an important number of hits at the very beginning of the test, and then a quieter period, before the increase of either the number of hits and their amplitude. The felicity ratio is 0.14, which confirms the poor quality of the material. It is interesting to notice that the number of hits is more important for the sensor 2 than for sensor 1, which is in accordance with the importance of the damage. The study of the amplitudes shows that soon after the beginning of the test, we record hits which amplitudes are higher than 80 dB and 90 dB. This is characteristic of fibers breaking, even at these low pressures. The results are displayed in the following set of graphs.

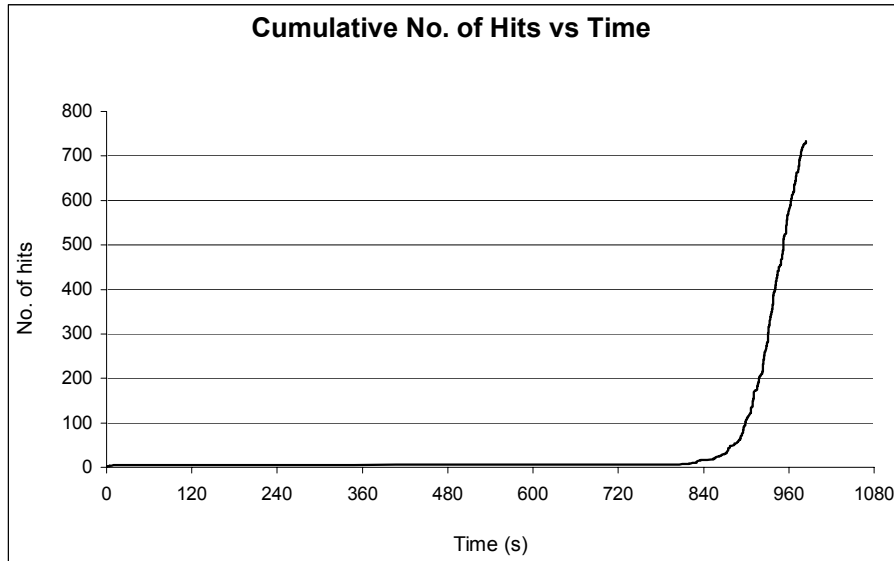
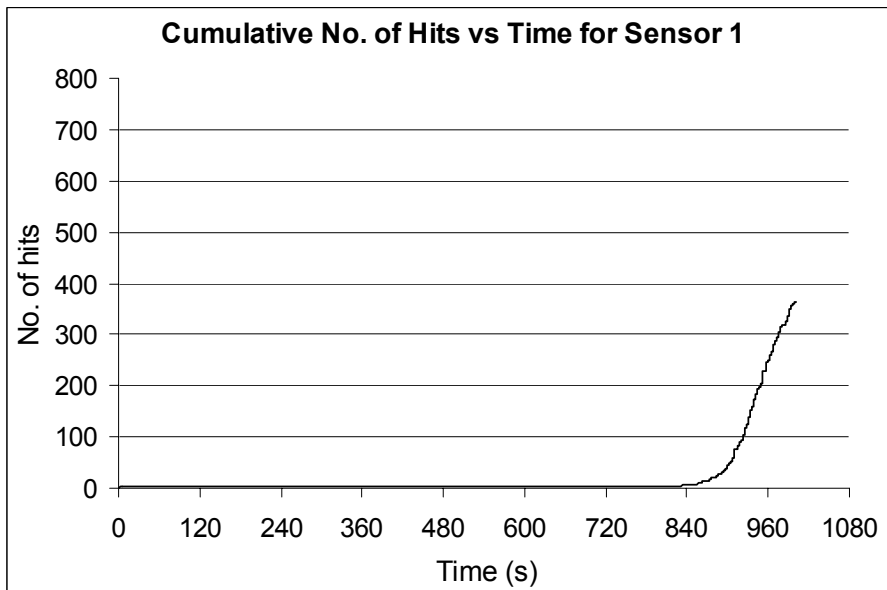
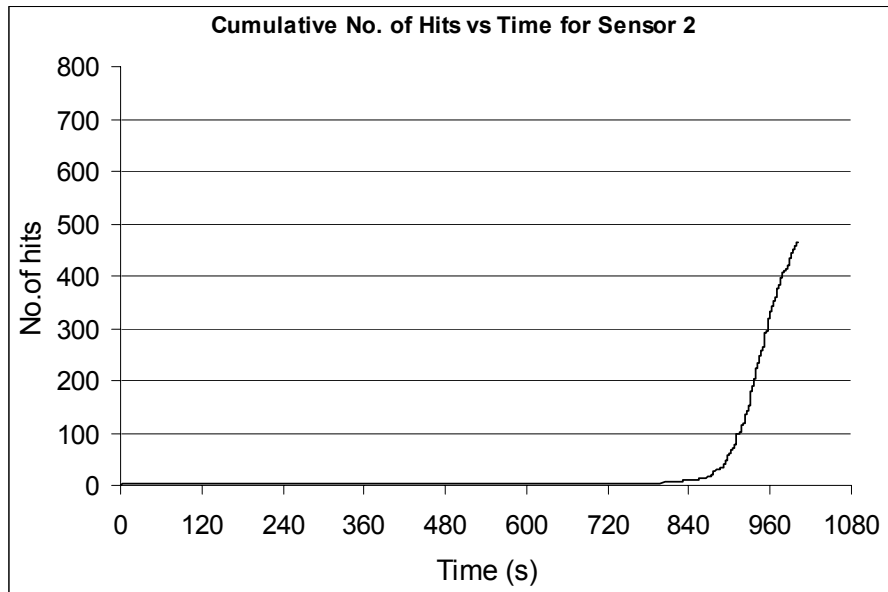
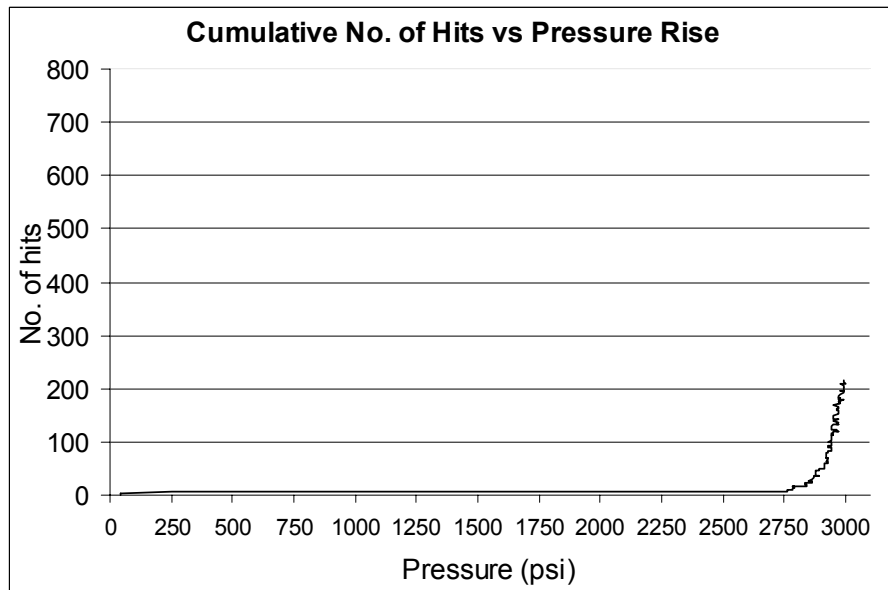
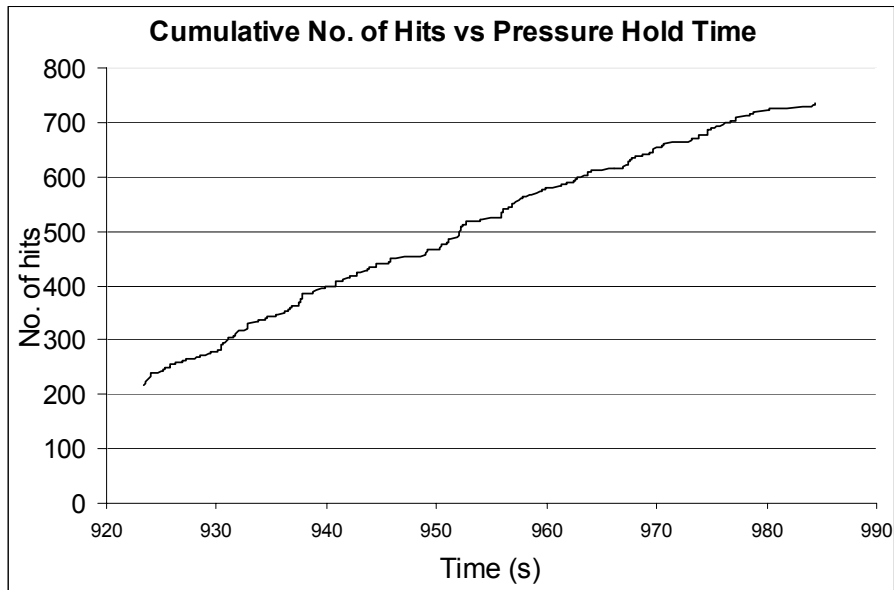
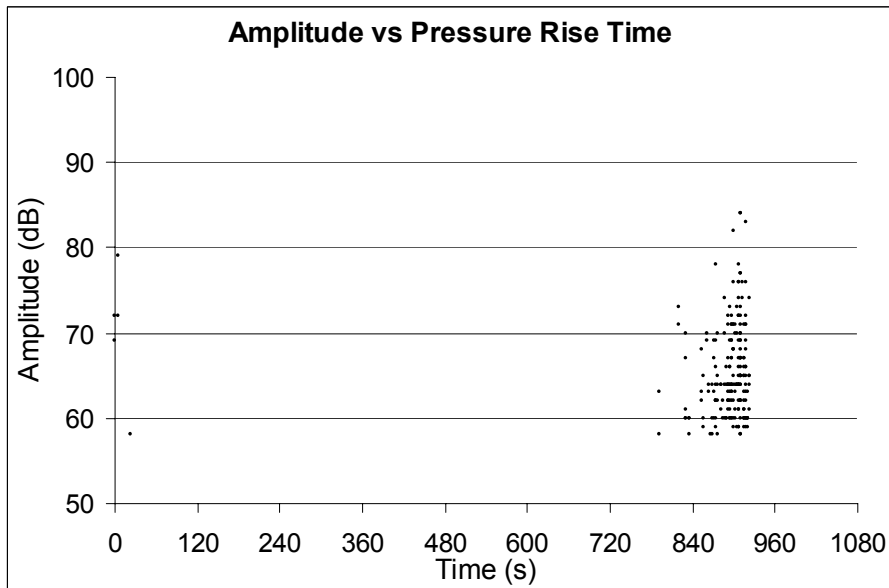
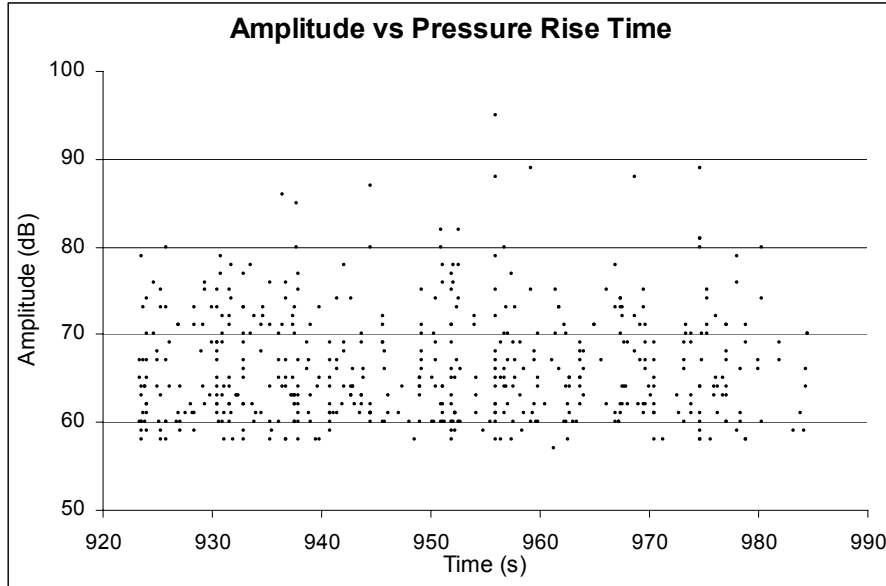
The results are typical for a good cylinder. The number of hits is a bit high, but they only occur after 190 bar (2750 psi). The felicity ratio is good : 0.92.

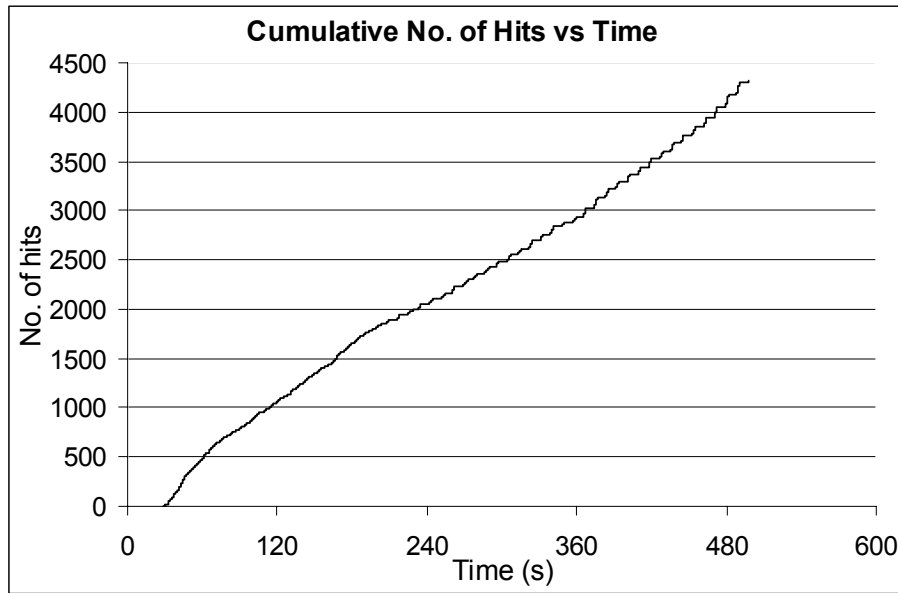
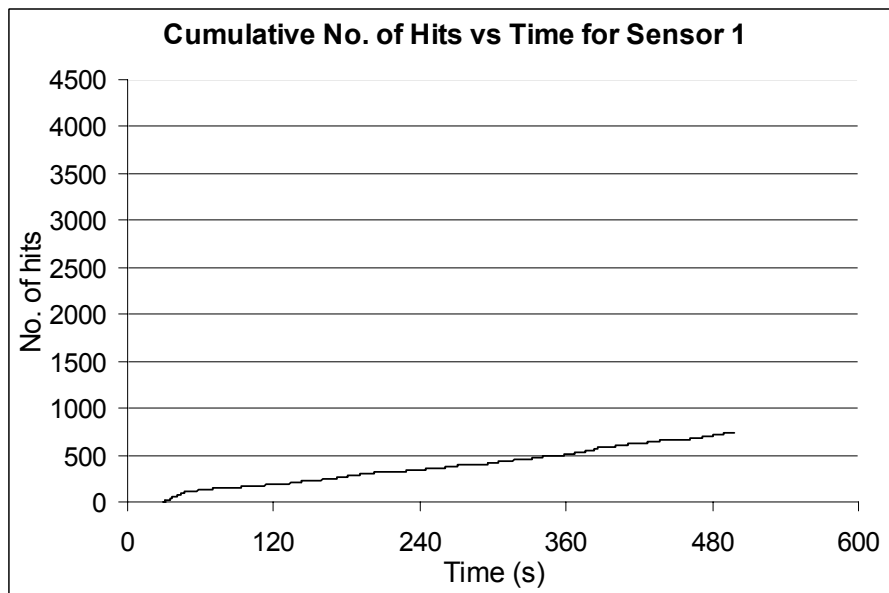
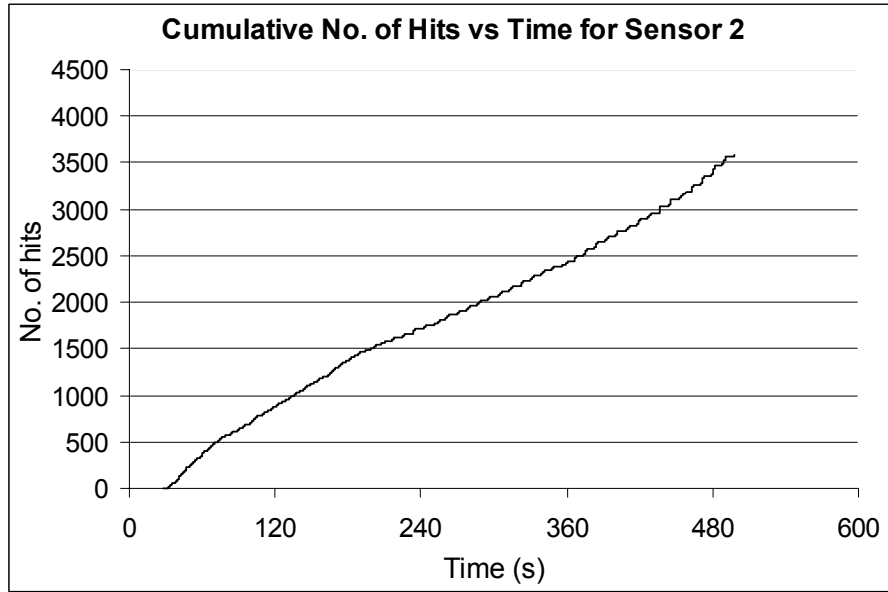
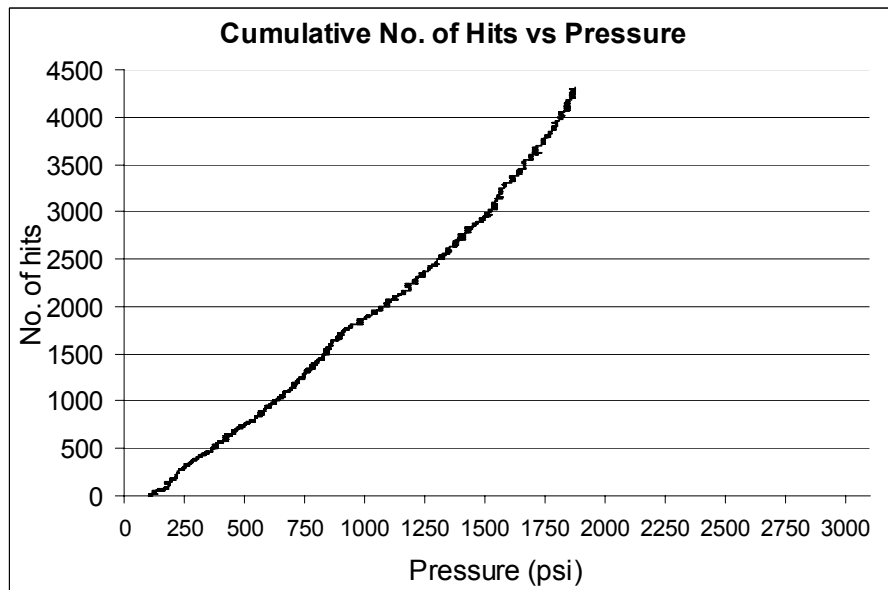
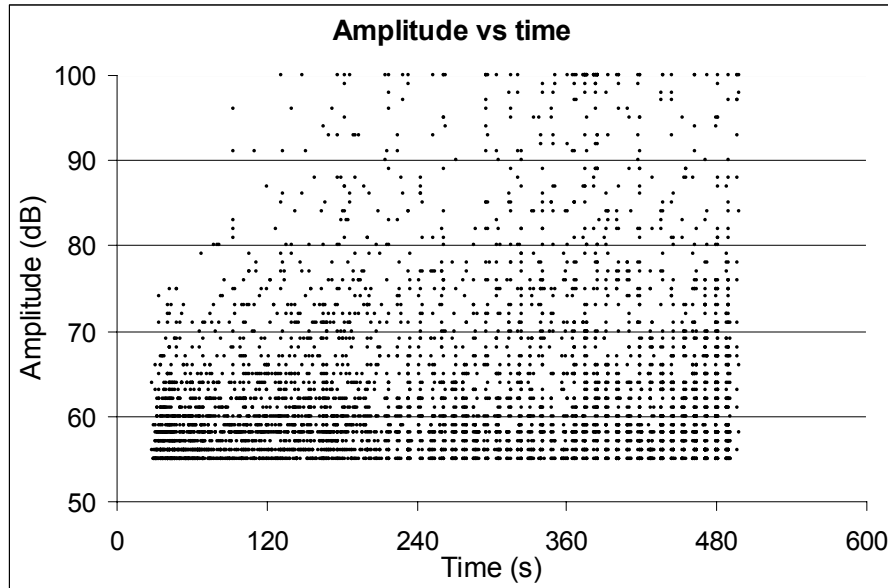
samples. But we can still notice that at the beginning of the test, the number of hits increases slightly faster, due to friction noise created by the delaminations inside the wrapping. Hits of high amplitude (100 dB) are recorded very early in the test, and the felicity ratio is still very low at 0.15, which clearly shows that the structure is damaged. The observation of the amplitudes shows that a high number of event with a very high amplitude start to appear very soon in the test, showing that the structure has been damaged.
